**CALSPAN ON-SITE AIR BAG DEPLOYMENT INVESTIGATION**

**CALSPAN CASE NO. 95-20**

**VEHICLE #1 - 1994 CHEVROLET CAMARO Z28 CONVERTIBLE  
(DUAL AIR BAG-EQUIPPED)**

**LOCATION - UTAH**

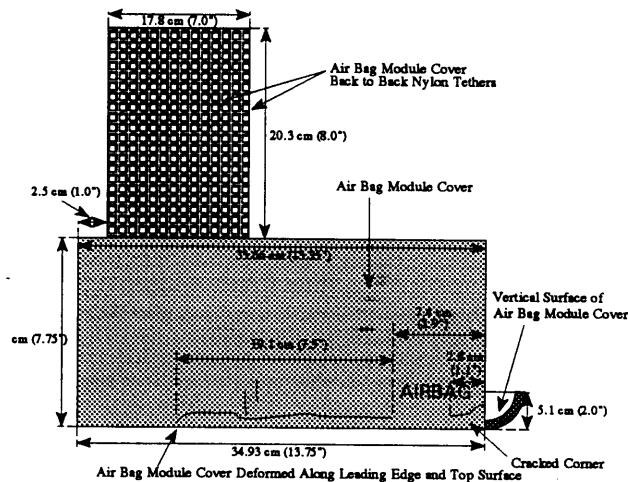
The air bag module flap separated along the predesigned tear points and contacted the windshield with the left side causing a spider web crack pattern and a black transfer from the right side adjacent to the right upper A-pillar.

The leading edge of the passenger side air bag module flap was deformed along a lateral area measuring 19.1 cm (7.5") on the vertical/horizontal surface. The pattern of the deformation suggested a downward fold (refer to photographs #88, #89 on pages A-44, A-45) which may have resulted from loading by the right front occupant during the deployment cycle. The right corner of the cover exhibited a crack which extended from the right edge inward 2.8 cm (1.1").

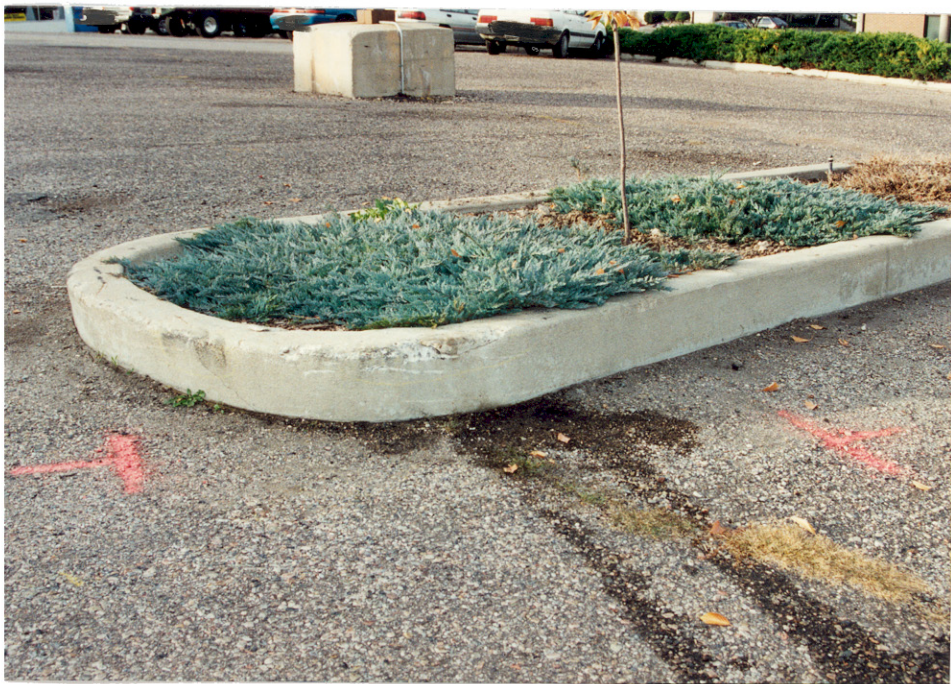
The rack and pinion housing immediately to the left of the skid plate and extending to the left 13.0 cm (5.1") also contacted the concrete curb. This contact fractured the housing and displaced the left side of the steering rack 3.8 cm (1.5") upward and rearward. Power steering fluid was released through the fracture site and was visible on the asphalt at the scene (refer to photographs #13-#14 on page A-7, #53 on page A-27).

14. Closer view of the POI. Leakage of power steering fluid from Vehicle #1's fractured rack and pinion housing can be seen by the darkened asphalt surface at the base of the curb.

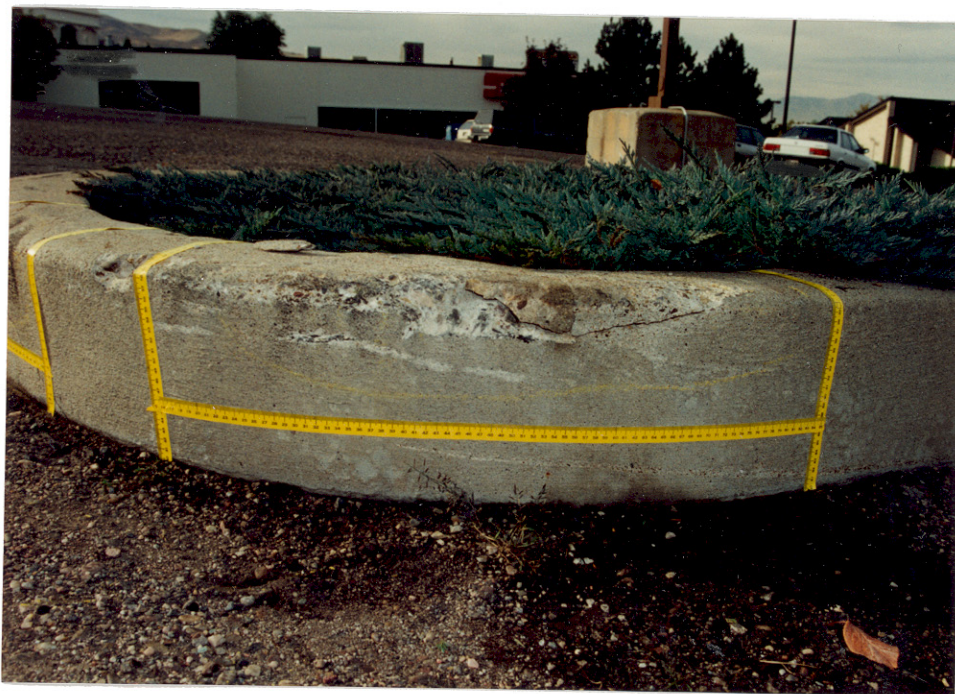
15. Close-up view of the curb showing contact by Vehicle #1's undercarriage.

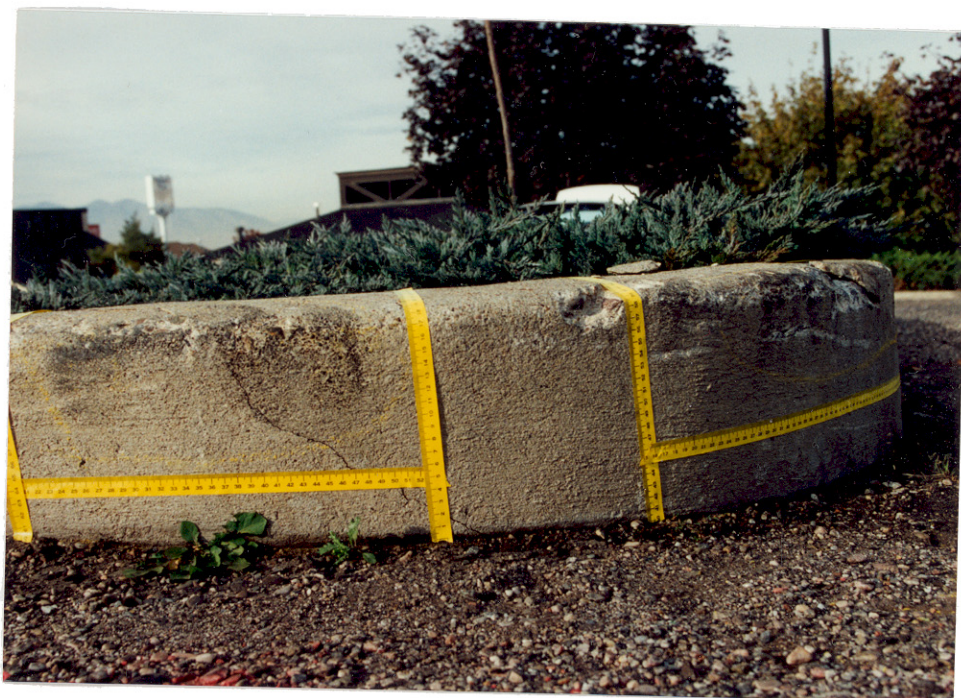
16. Close-up view of the curb showing contact by Vehicle #1's left front tire.

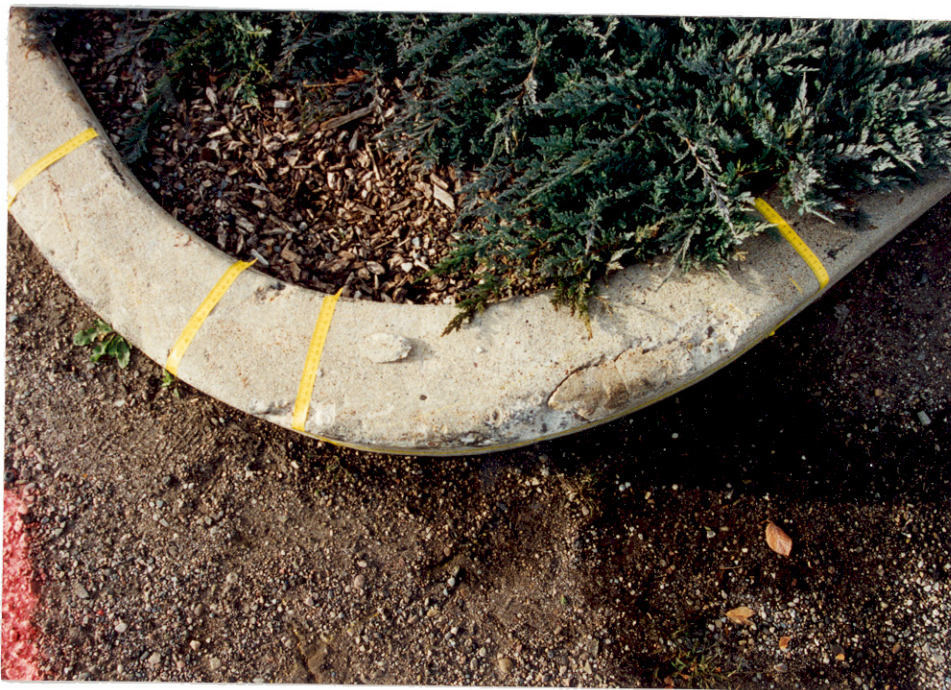
17. Overhead view of the POI showing the undercarriage contact pattern and the left front tire contact.

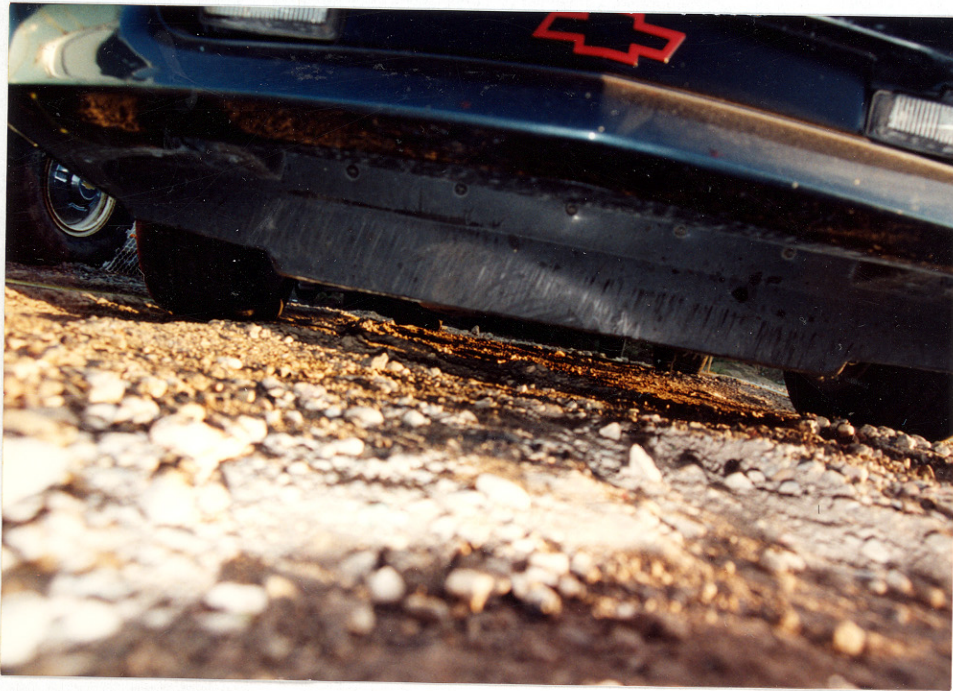
47. View of the front air dam showing curb impact gouges .

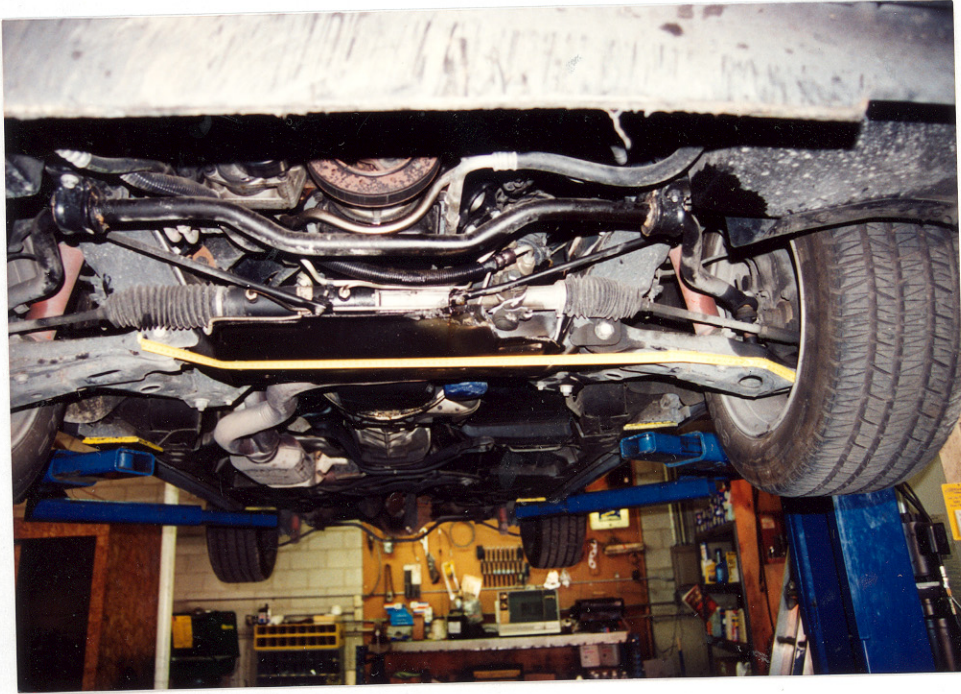
The second undercarriage contact point involved the front anti-sway bar. Due to the stiffness of this component and the observed concrete residue noted on the bar (refer to photographs #49, #50 on page A-25), it was hypothesized the magnitude of this contact was sufficient to decelerate the vehicle and close the arming sensor.

49. Overall view of undercarriage components. The primary areas of interest include the front air dam at the top of the photograph, the front anti-sway bar, the leading edge of the engine frame cross member (i.e., skid plate), and the rack and pinion power steering housing.

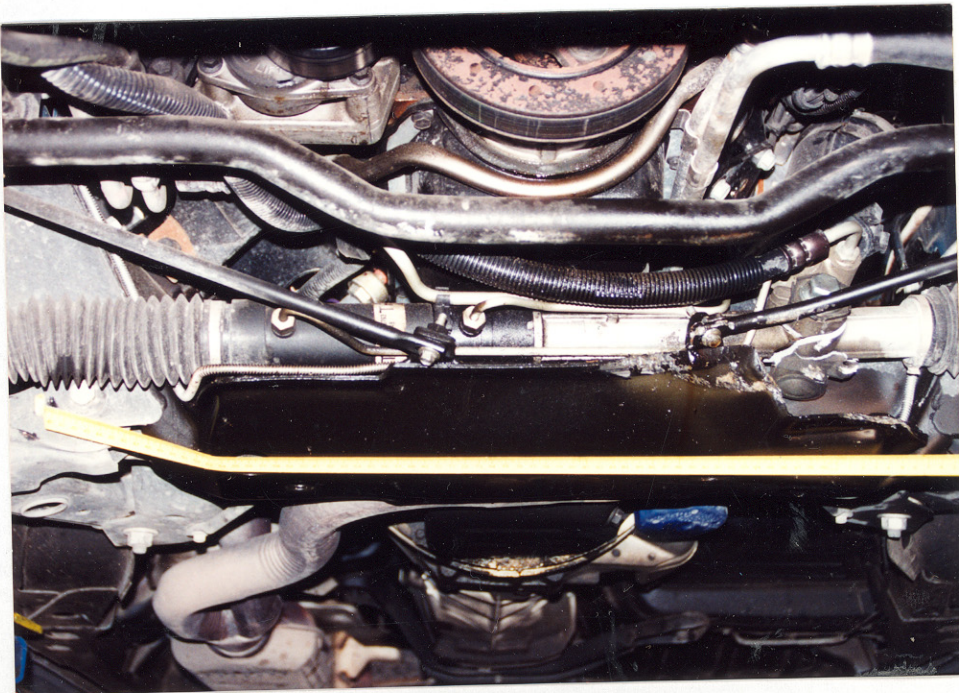
50. Closer view of the front anti-sway bar, the skid plate, and the rack and pinion power steering housing.

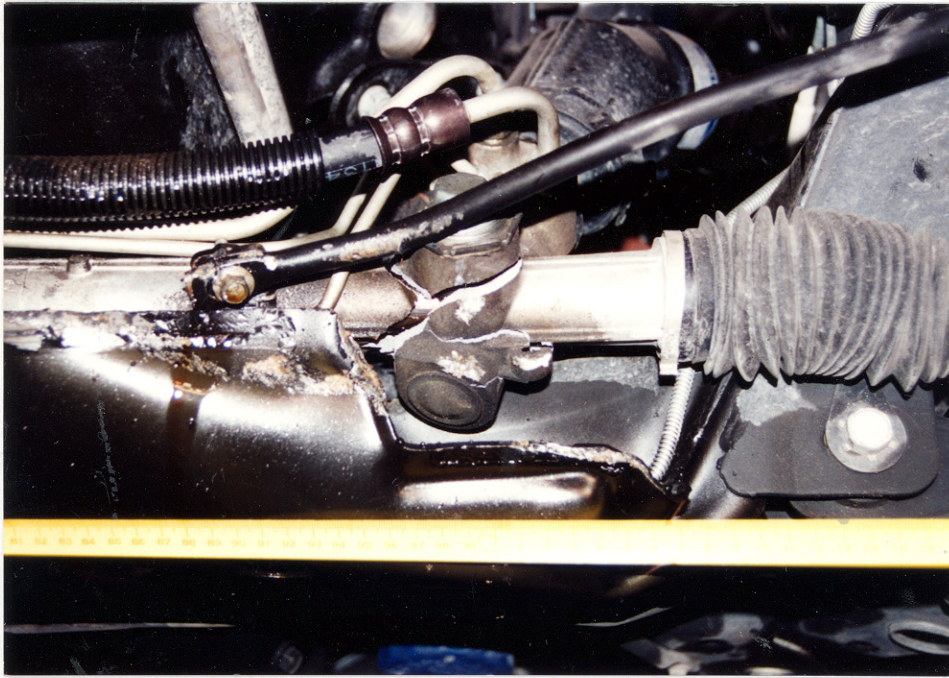
The rack and pinion steering assembly was the next component contacted which resulted in a fracture of the housing and a rearward/upward displacement. Power steering fluid was released through the fracture point and spilled onto the ground.

53. Close-up view of the skid plate deformation and the fractured rack and pinion housing.

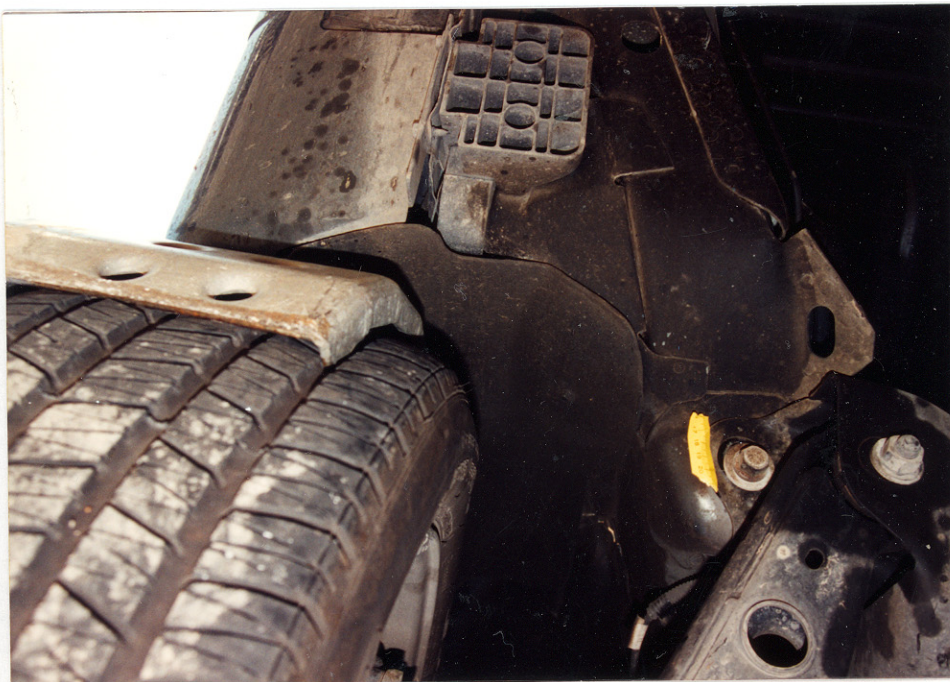
The engine cradle was displaced rearward 12.7 mm (0.5") as the result of the contact sequence. The left front tire contacted the curb as noted in the scene photographs and subsequently rebounded slightly as noted in on-scene photograph #22 on page A-11.

54. View of the 12.7 mm (0.5") rearward movement of the engine cradle as measured at the left rear engine cradle bolt.

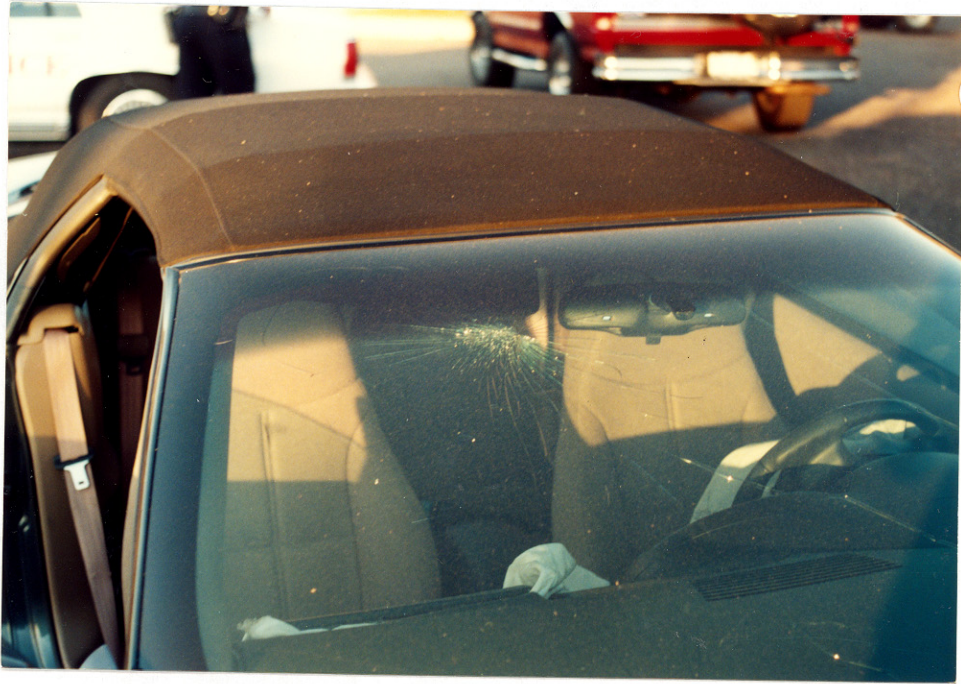
65. Police on-scene photograph of Vehicle #1 showing the crack in the windshield which resulted from contact by the air bag module cover.

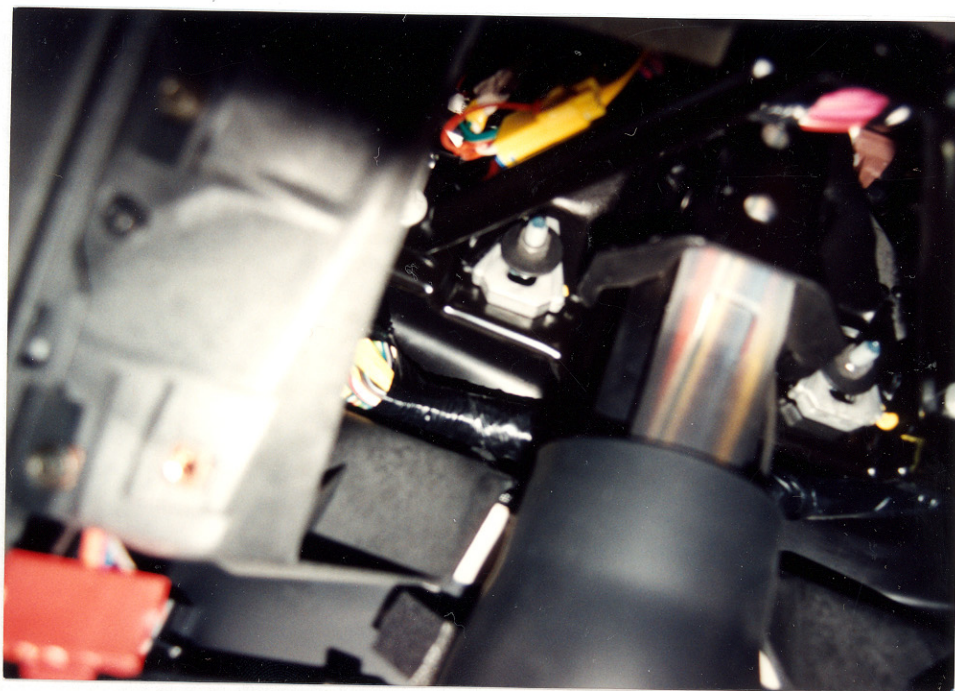
The steering wheel rim was not damaged and the steering column shear capsules were not displaced. The front wheels did not respond to steering wheel turning input applied during the post crash vehicle damage evaluation. Damage to the rack and pinion allowed the turning of the steering wheel, but the steering linkage reacted independently. The position of the steering wheel rim at the final rest position (FRP) was rotated approximately 180° as seen in on-scene police photographs.

76. View of the steering column shear plate and capsules which shows no movement from occupant loading.

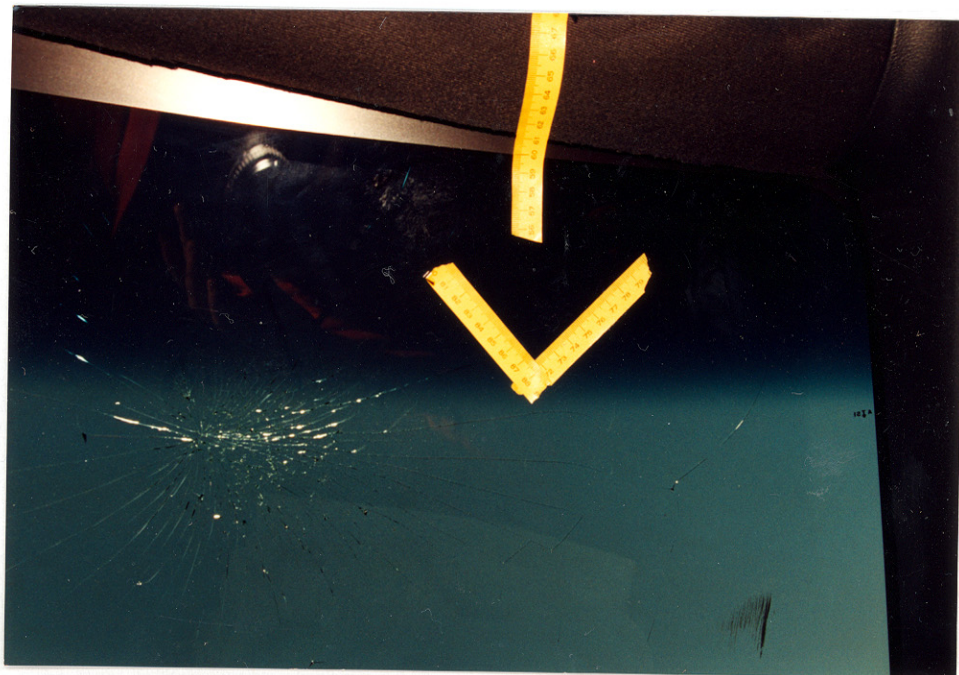
The passenger side air bag module flap separated along the predesigned tear points and contacted the windshield with the left side causing a spider web crack pattern (refer to photographs #83, #84, #87 on pages A-42, A-44). The right side of the cover also contacted the windshield resulting in a black transfer mark adjacent to the right upper A-pillar.

83. View of contacts by the right front occupant on the windshield and windshield header which were noted by yellow calibrated tape.

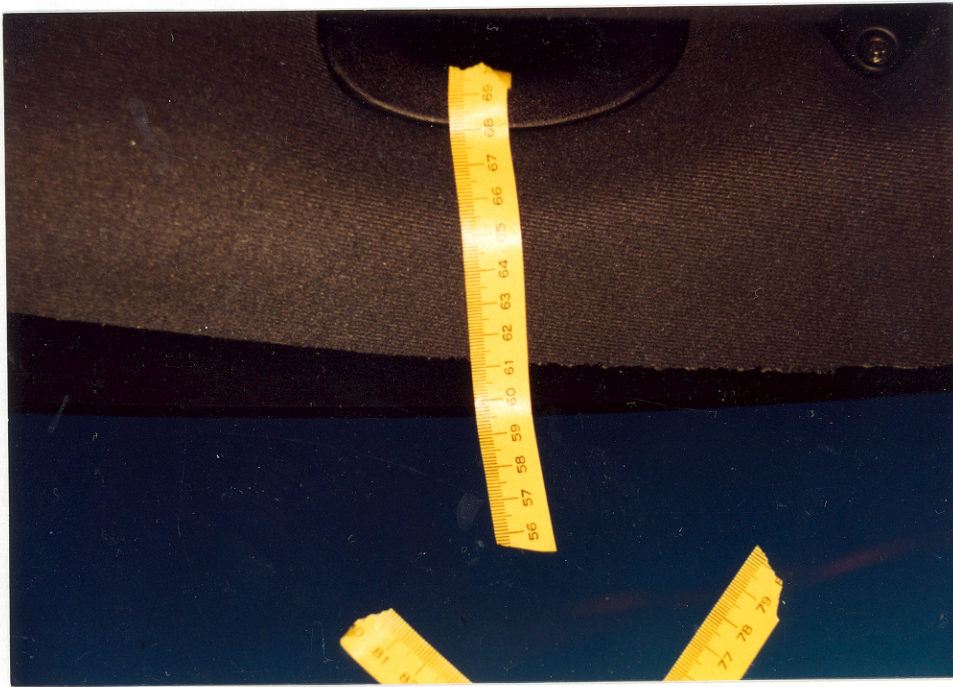
84. Closer view of the windshield and windshield header contact points. The star pattern in the windshield and dark transfer mark near the A-pillar on the windshield were the result of contact by the passenger side air bag module cover during the deployment sequence.

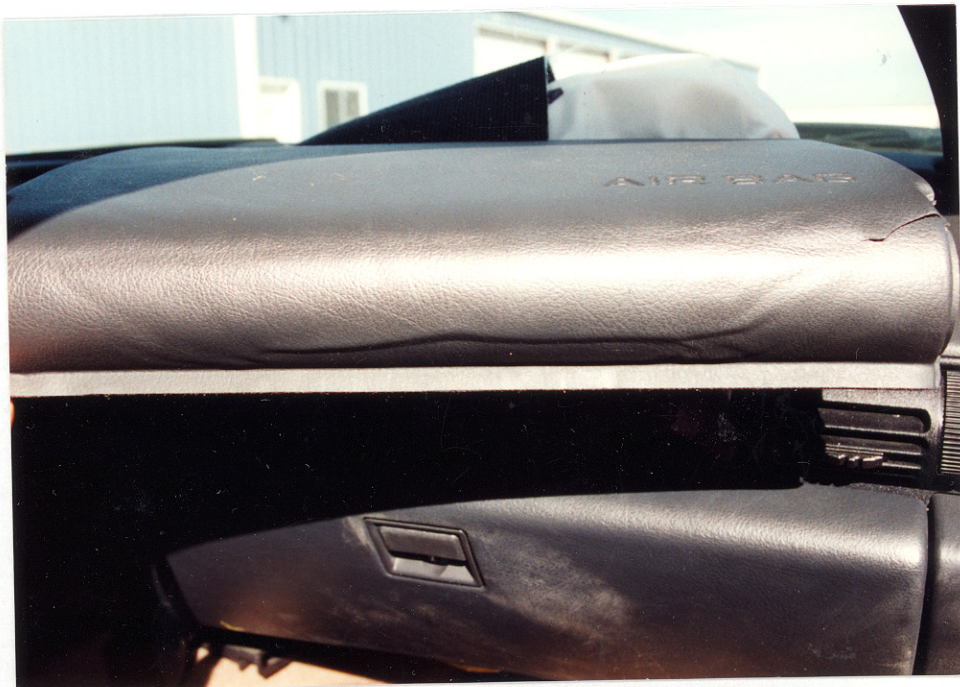
The leading edge of the passenger side air bag module flap along a lateral area measuring 19.1 cm (7.5") was deformed (refer to photograph #88, #89 on pages A-44, A-45) as the result of contact with the right front occupant's head/face. The right corner of the cover exhibited a crack which extended from the right edge inward 2.8 cm (1.1").

88. Close-up view of the leading edge of the passenger side air bag module cover.
